SECTION I  
INTRODUCTION

At about 1645 hours on Friday, 6 July 1973, a heated, pressurized tank of nitrous oxide ( $N_2O$ ) exploded and burned on B-8 test stand, where preparations were underway for testing an  $N_2O$ -CO laser combustor. Although there were no personal injuries, significant property damage occurred.

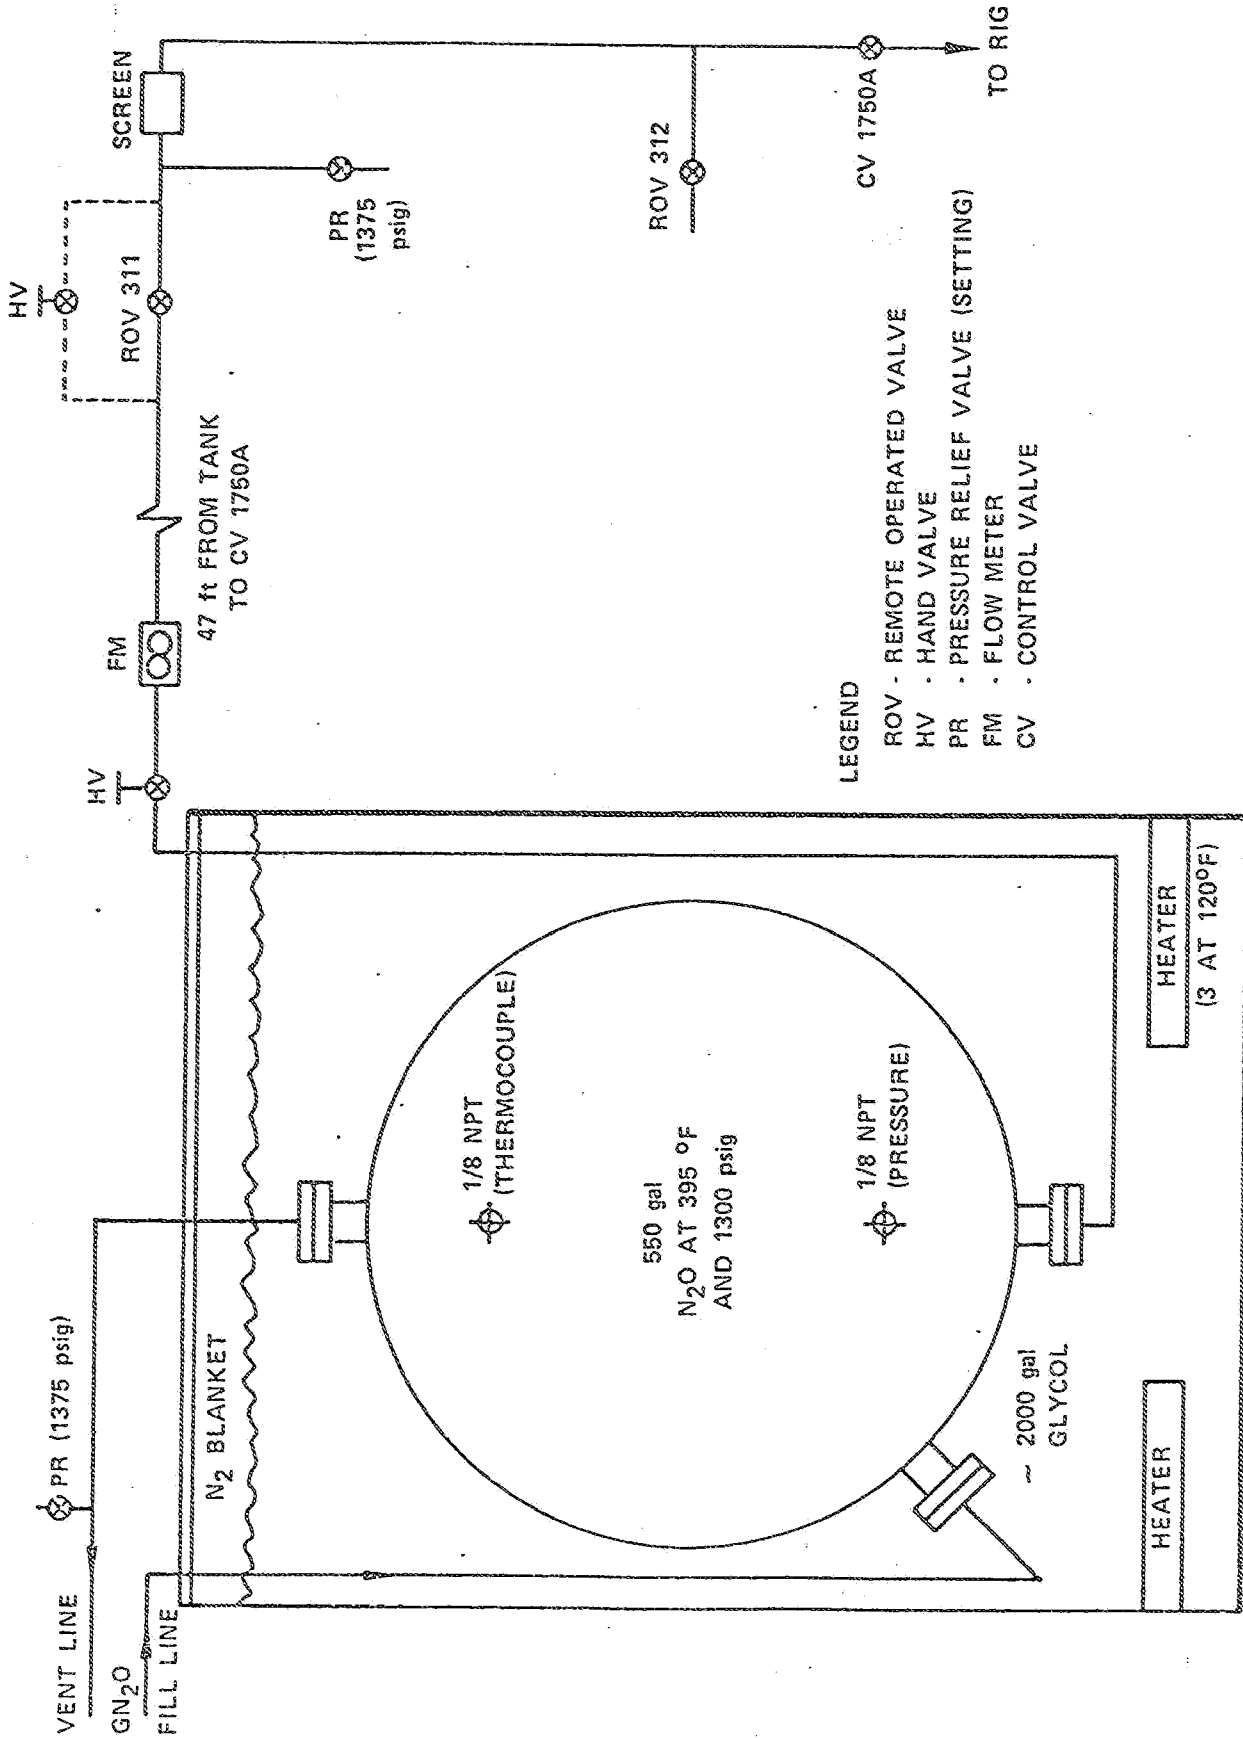
Figure 1. Equipment Associated With Explosion

A schematic drawing of the equipment associated with the explosion is presented in figure 1. The pressure vessel holding the  $N_2O$  gas was made of 304 stainless steel, had walls 1-1/2 in. thick and had four access openings. Two 3-in. flanged connections were welded, one each, to the top and bottom of the tank. In addition, the tank had been drilled and tapped at two points for a 1/8-in. pipe thread. An immersion type chromel-alumel thermocouple was mounted in the upper threaded hole and a pressure sensing line was connected to the lower one. Gaseous  $N_2O$  was admitted to the tank through a 3/4-in. stainless steel line connected to the top flanged fitting and  $N_2O$  was withdrawn from the tank through the bottom flanged fitting. Both the supply line to the top and the run line from the bottom were connected to pressure relief valves set to open at 1375 psig. The tank is reported to have been hydrostatically tested to its working pressure (1800 psig at 70°F) in October 1972.

Moving downstream from the tank, the  $N_2O$  passed successively through a hand valve, a turbine type flowmeter, a remotely operated pneumatic valve, a screen type (100 mesh) filter and the final control valve. All components of the system were stainless steel except for the thermocouple in the run line which was barewire chromel alumel. The system was completely lox-clean and thoroughly dried and purged before being charged with  $N_2O$ .

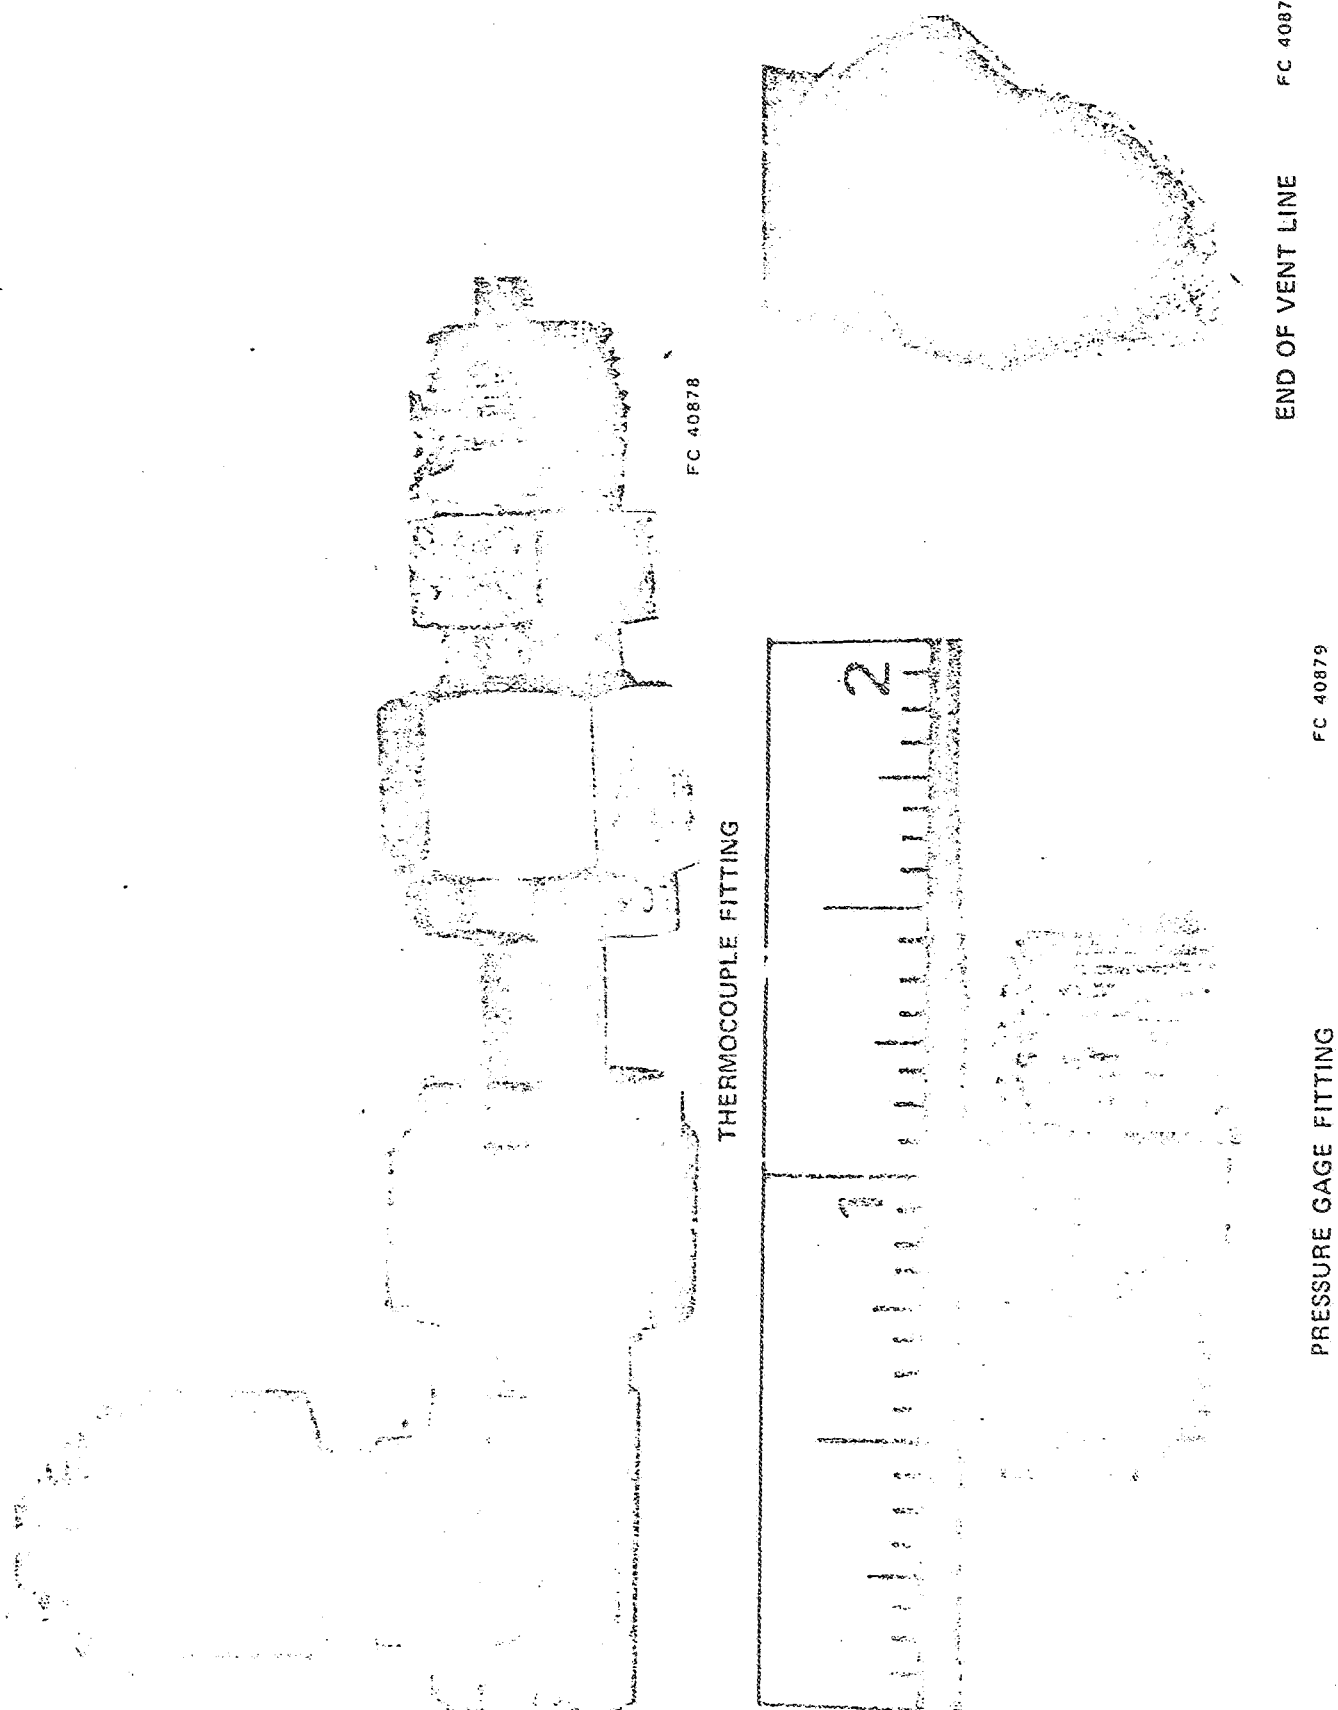
The pipe threads show evidence of being strained as they were forced from the tank by excessive internal pressure, presumably shearing the threads out of the softer tank material in the process, but they do not show any evidence of heat. Even the Teflon tape that was wrapped around the threads as a sealant was not damaged, proving that the fitting temperature never exceeded about 700°F. The main run line is still attached to the bottom of the tank and shows no visible indication of damage other than a small bulge. The flowmeter vanes, however, do show discoloration from excessive heating and the screen located between ROV 311 and CV 1758 has been burned. Neither the flowmeter nor the screen show any evidence of pressure deformation. Both pressure relief valves, which were set to open at 1375 psig, have been damaged. The Teflon seat is completely burned out of one and the metal seat is burned on the other. The  $N_2O$  tank itself was shifted within the bath by the propulsive force of the  $N_2O$  issuing through the holes.

Figure 6. End of Vent Line and Pressure and Thermocouple Pipe Fittings

8. The  $N_2O$  tank thermocouple was found on the stand with the 1/8" pipe fitting still attached to it. The threads on this fitting are rolled back indicating it blew out of the tank. The fitting is not burned. The thermocouple is bent but not burned.
9. The aluminum glycol tank cover has a slight amount of black discoloration and is bent and gouged in an area which was directly over the tank top flange. This indicates there was flame hitting the aluminum at this location for a short period of time prior to the flange hitting it when the explosion occurred.
10. The south side of the inside of the glycol tank has black flame impingement marks at the same elevation as the  $N_2O$  tank top. This indicates flame came out of the tank top and deflected off the 3" - 1500 lb. flange prior to the flange blowing out.

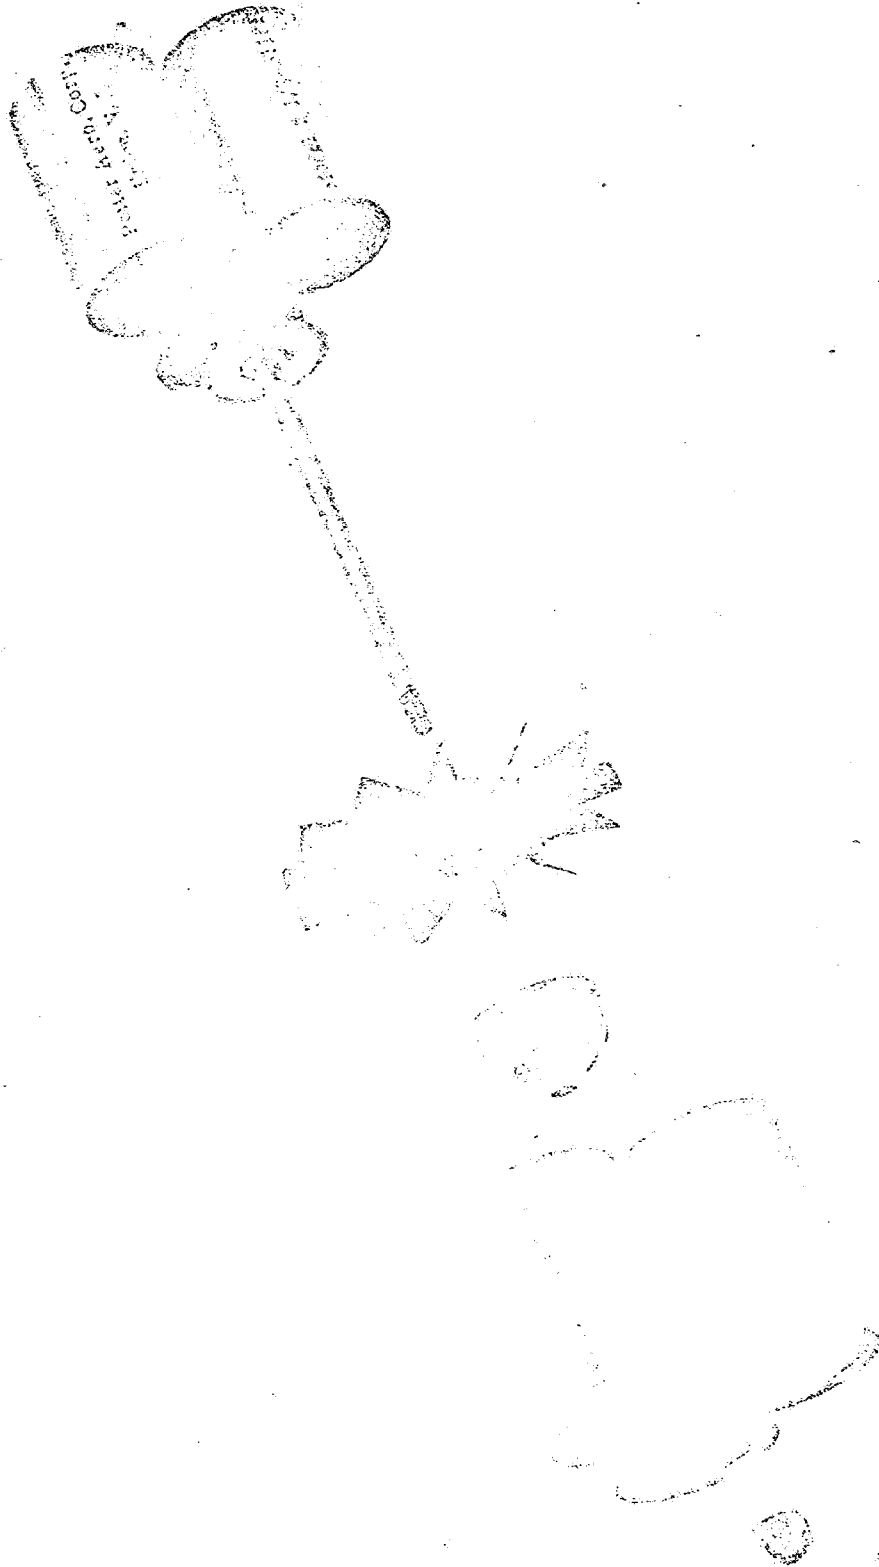
5. The flowmeter bearing cage material may have burned or acted as a catalyst. It is not known at this time what the cage material was. The cages are missing from both bearings. This material could have been burned out after ignition occurred.

FC 40960. Potter Flowmeter Disassembled
